**Botanical Environmental Impact  
Survey for the Proposed Dredging  
of the Nadi River and Estuary  
IAS Technical No. 2001/2**

**INSTITUTE OF APPLIED SCIENCES  
THE UNIVERSITY OF THE SOUTH PACIFIC**

**Marika Tuiwawa  
Alifereti Naikatini  
South Pacific Regional Herbarium**

**June, 2001**

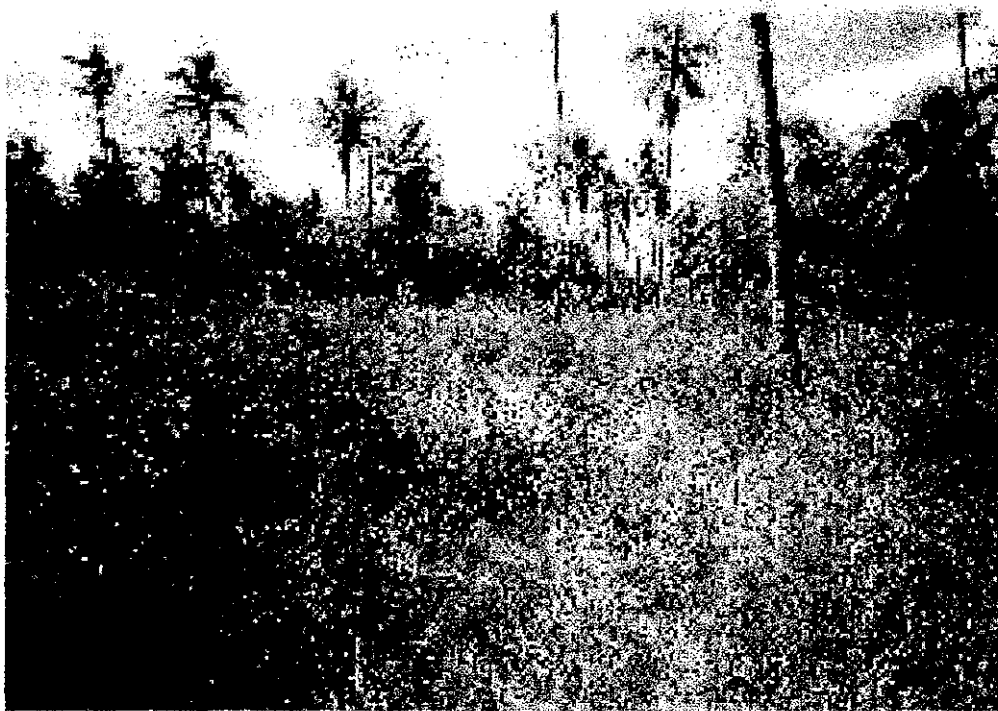
Figure 3. Proposed dumpsite at the Nacova Islet that's adjacent to the saltmarsh. The vegetation is mostly composed of weeds associated with neglected gardens and pastures.
