**INSTITUTE OF APPLIED SCIENCES
THE UNIVERSITY OF THE SOUTH PACIFIC**

**BASELINE ECOLOGICAL AND WATER
QUALITY STUDIES OF WAINIVESI AND
WAINAMAKO CREEKS, TACIRUA**

IAS ENVIRONMENT REPORT NO. C188

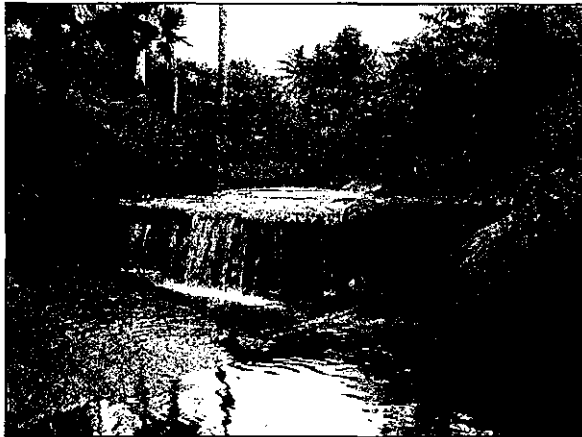
Photo 1. The small waterfall upstream

Site 1 was within Wainivesi Creek and was accessed from Caubati Road. It was just downstream from a small pool and a small waterfall of about a meter in height. The surrounding topography was hilly and fairly steep on the Caubati side which was planted with cassava. Other flora on creek banks were breadfruit and banana trees and paragrass and was fairly disturbed. Fauna present included insects such as dragonflies. Creek width was around 3 meters and depth around 10 cm. Creek flow was a slight steady flow. The creek bed was silty with a few stones. Aquatic fauna observed were gastropods, tadpoles, shrimps and small fish.

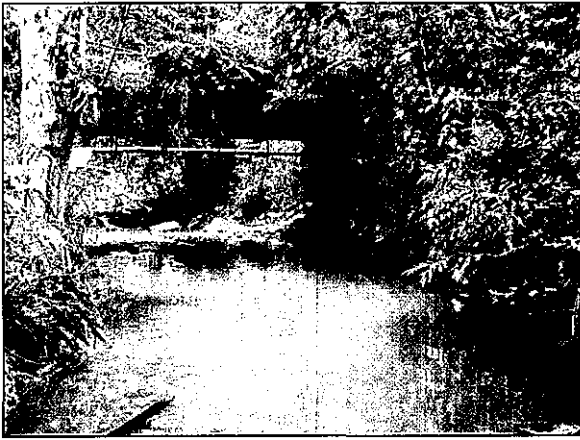
Photo 5. Site 3 looking downstream to the bridge *Photo 6. Sampling with the net*

Site 3 was within the lower part of Wainamako Creek. Access was at the end of Church Road and the site was close to a bridge crossing over the creek. Surrounding topography was slightly hilly but not as steep as Site 1 and 2. Surrounding vegetation was disturbed and included guava, African tulip, and breadfruit trees, ferns, and ginger plants. Creek width was around 6 meters and depth 40-50 cm. Flow was slight. The creek bed was silty with rocks present. There was sandstone on one bank. Moss was observed on the rocks. Aquatic fauna observed included small fish and water spiders. A lot of rubbish and debris was again observed on the banks from the recent floodwaters.

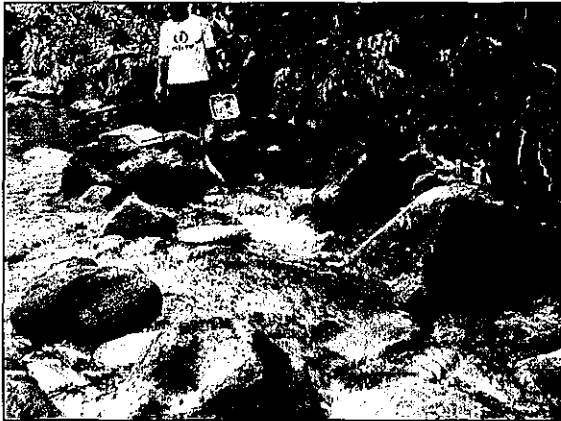
Photo 9. Site 4 showing small area of rapids

Site 4 was also within Wainamako Creek but upstream from Site 3. Access was from Seru Crescent and along a path of about 200 meters. It was in a small area of rapids just upstream from a large pool where a small waterfall dropped into the creek. The pool was used by the nearby residents for swimming. Surrounding topography was hilly on the cunningham side and very steep, cliff-like on the development side of the creek. Surrounding vegetation was disturbed and planted with cassava on the hilly side and forest on the development side. Creek width was around 3 m and depth 30-50cm. The creek bed was sandstone with large boulders. Flow was steady and fast. Moss was again observed on the boulders. Many gastropods were observed on the creek bed. Rubbish from the recent flooding which was about 1 m higher than the present water level, was again observed.
