DRINKING WATER QUALITY IN A
NUMBER OF SOUTH PACIFIC ISLAND
COUNTRIES
INR TECHNICAL REPORT NO. 82/1

Drinking Water Quality in a Number of South Pacific Island Countries

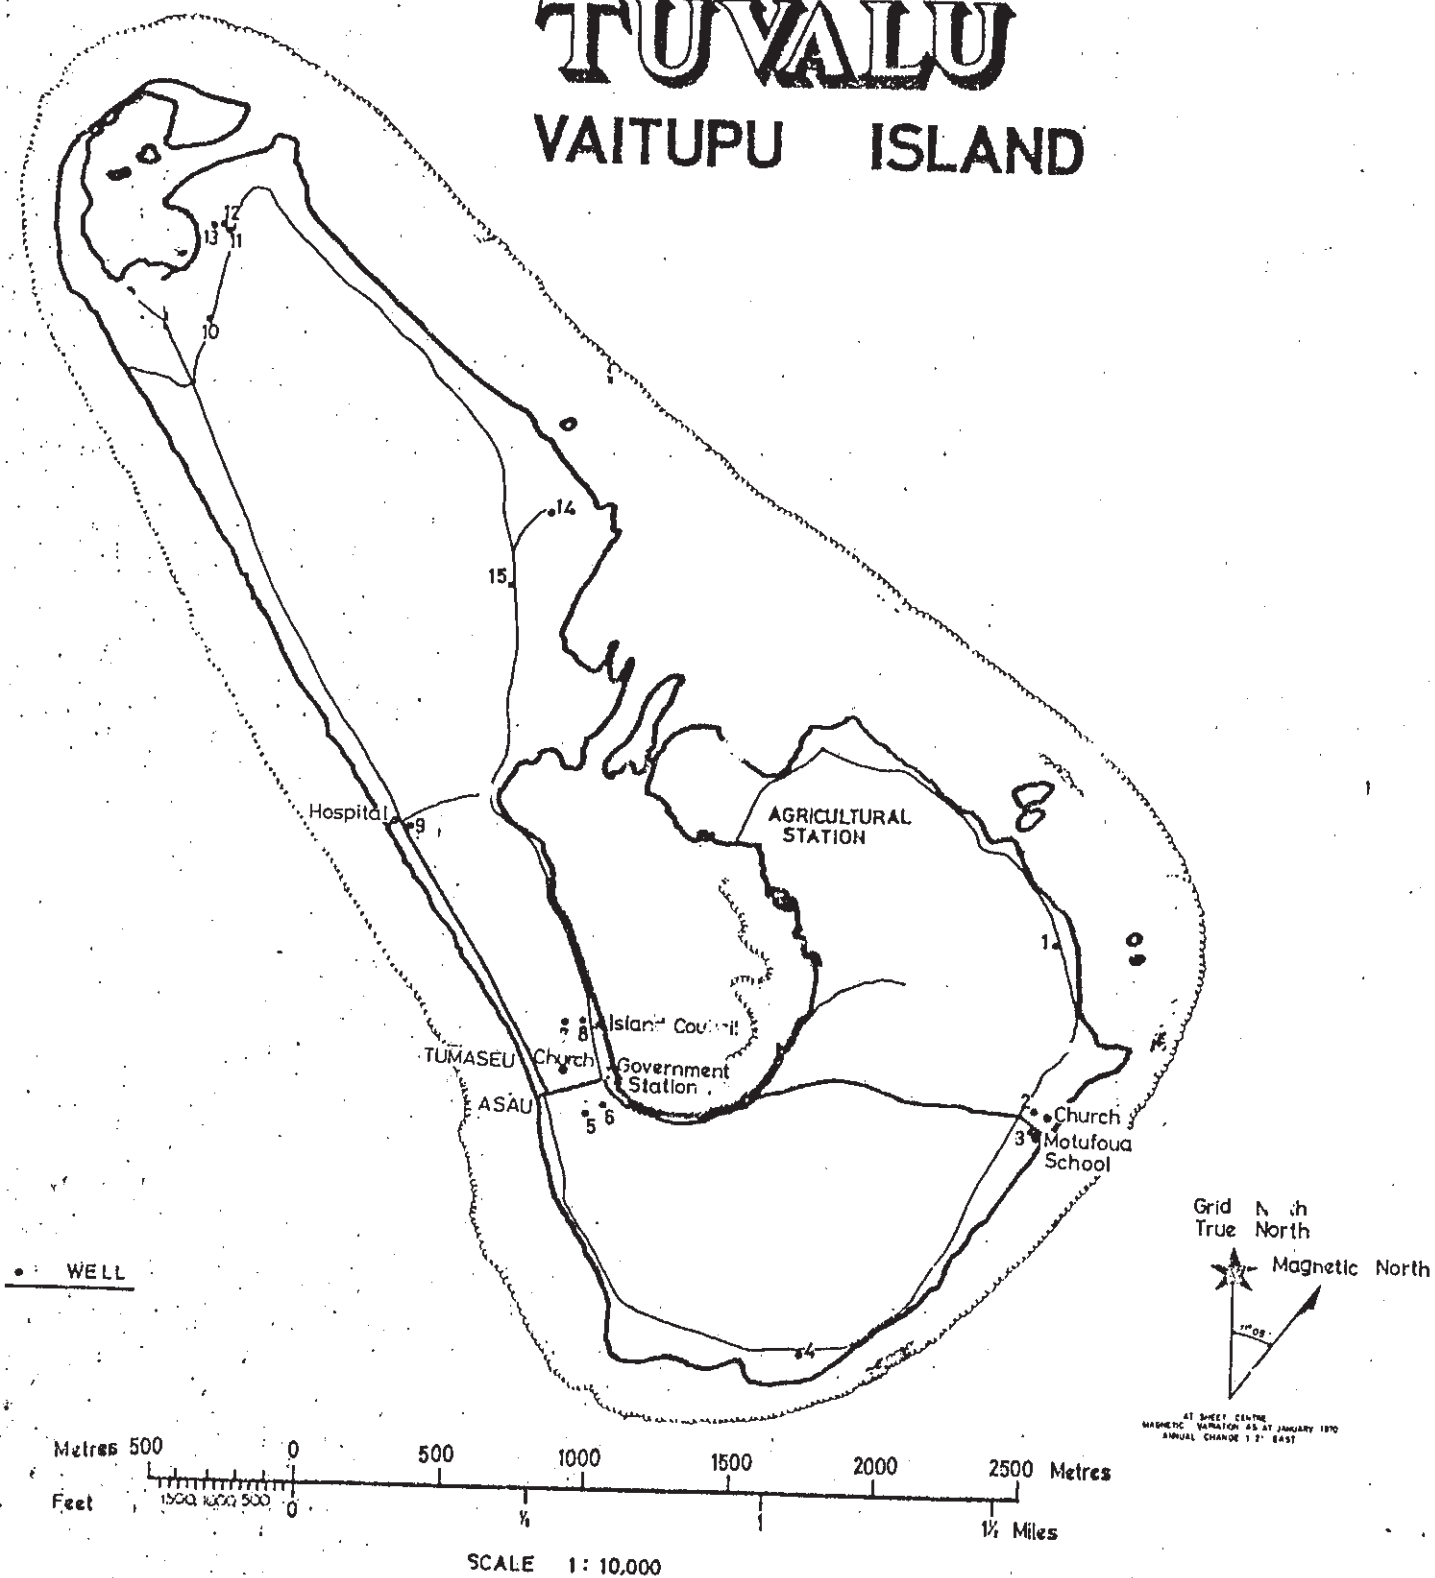
MAP 1

the water was observed, even though the analyses were done when a drought of two weeks duration was broken by rainfall of 35mm. The results of analyses appear in Table 1. Well numbers correspond to the numbers on Map 1. All known wells on the island are marked on the map.

VAITUPU ISLAND

Most of the wells on Vaitupu are contaminated to a greater or lesser extent by seawater and are therefore only suitable as a source of washing water. Wells close to the more inhabited area at the southern end of the island have also high levels of coliform contamination. However, the wells at the northern end of the island, No. 10, 11, 12 and 13 are a source of acceptable quality drinking water and development work on further wells in this area by the SPC will now proceed.

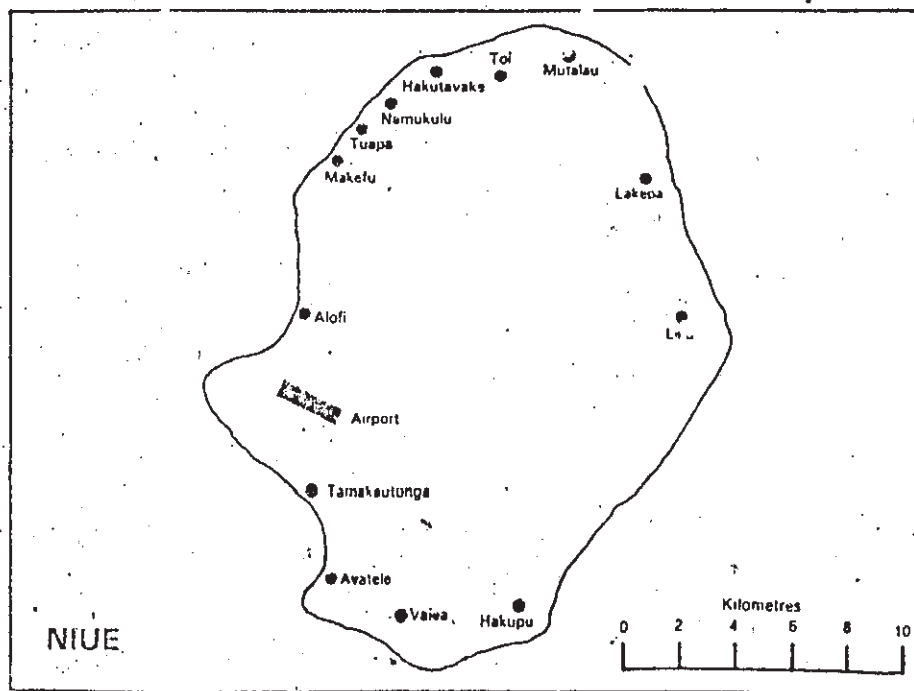
MAP 2

Seventeen bores and four rainwater tanks were tested in the present study. The results are shown in Table 2 and the bore locations on Map 2. Some bacterial contamination was noted and the high coliform count in the High School rainwater tank ascribed to the presence of a small dead animal in the tank. Further work to measure Fecal Coliform/Fecal Streptococci ratios and hence trace the source of bacterial contamination is now being planned.

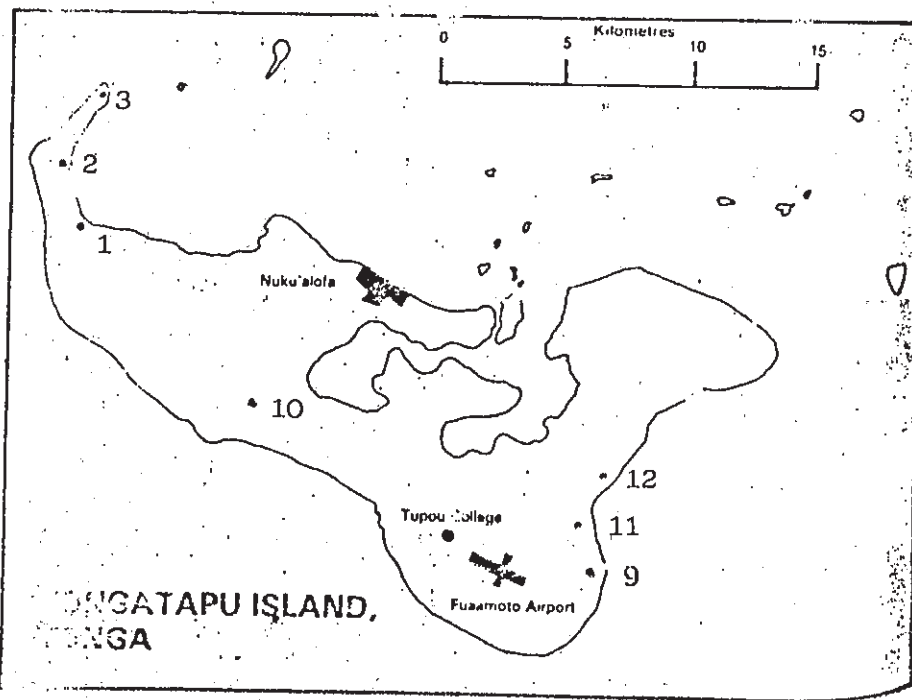
MAP 3

Twelve heavily used bores were chosen for testing in the present study on the advice of the Medical Officer for Health. The results are shown in Table 3 and the bore locations on Map 3.

As can be seen from the results salt water intrusion is becoming a problem in a number of the bores (Nos. 1, 2, 3 and 12). Two of the bores also show signs of bacterial contamination. Since aquifers in coral formations such as in all the cases in this study are invariably unconfined contamination from surface pollution is always a problem. Further work in the outer islands of Tonga is now being planned.
